NASA Contractor Report 165784

**Effect of Matrix Resin on the Impact Fracture
Characteristics of Graphite-Epoxy Laminates**

Boeing Commercial Airplane Company
Seattle, Washington

Prepared for
Langley Research Center
under Contract NAS1-15107

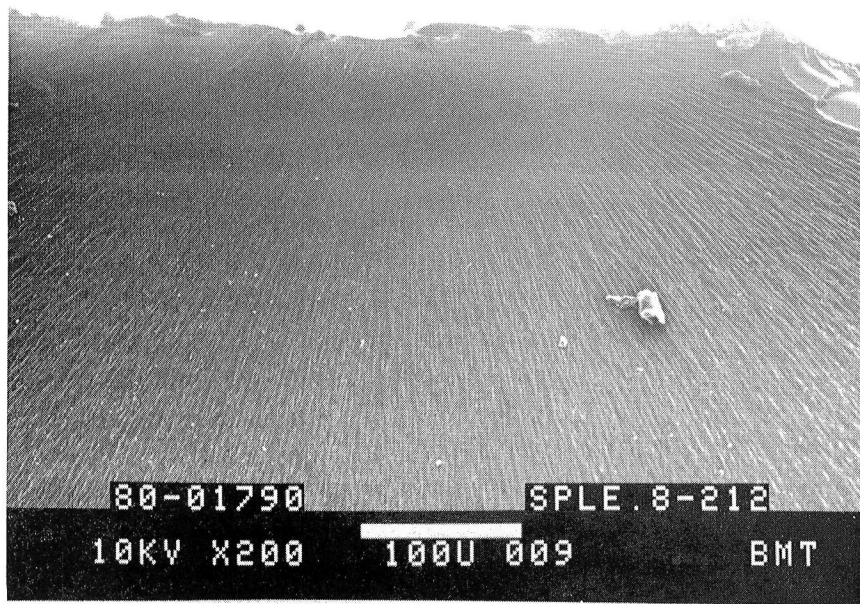
Figure 7. Neat Resin Fracture, Narmco 5208 (200X)

Narmco 5208 (fig. 7) is a tetraglycidylmethyle dianiline (TGMDA)-diaminodiphenyl-sulfone (DDS), 177°C (350°F) curing epoxy with good high-temperature properties, low strain to failure, and brittle fracture behavior. This brittle behavior is manifested in the smooth, glassy cleavage planes found in the fracture face, as well as the well-defined origin zones and transverse cleavage planes perpendicular to the direction of crack propagation. Figure 7 describes the classically brittle case, and the features seen at low magnification continue as increasing magnification is used (figs. 9 and 10). There is little ductility in this material and no deliberate introduction of second-phase elastomer or elastomer modification of any kind.

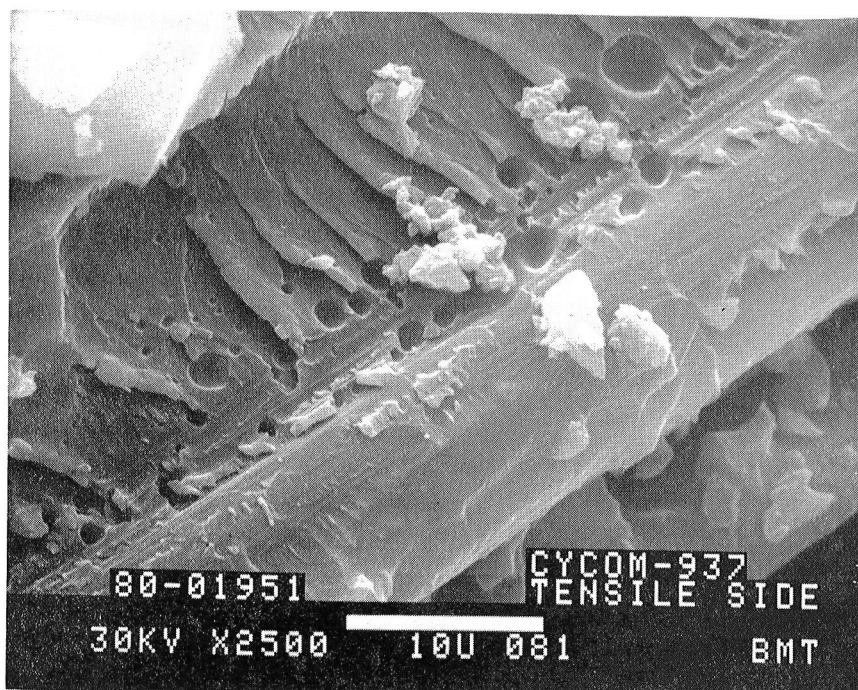
Figure 19. Resin-Fiber Bonding, Cycom 937 (2500X)

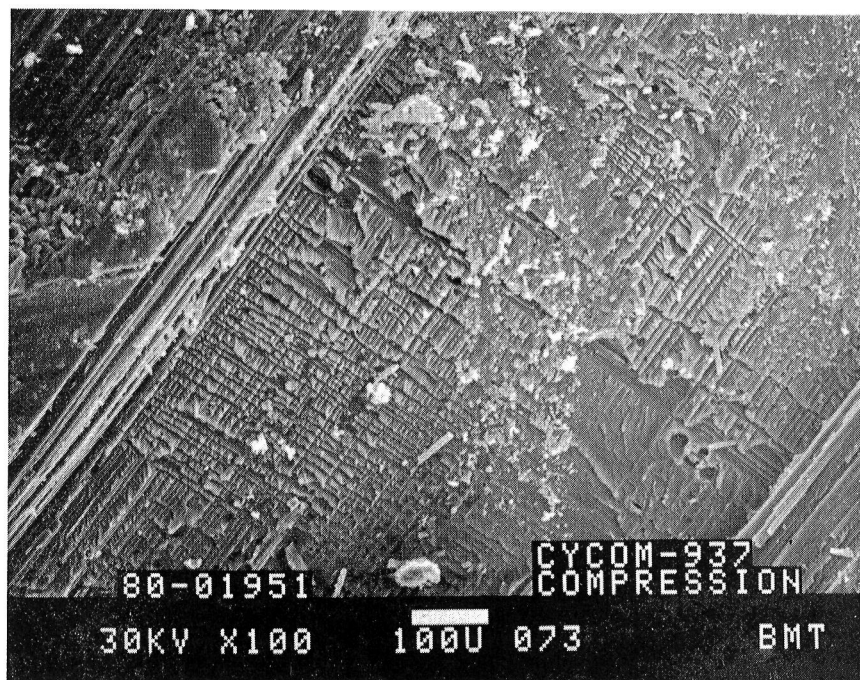
Figure 23. Compression-Loaded Interlaminar Shear Failure, Cycom 937 (100X)

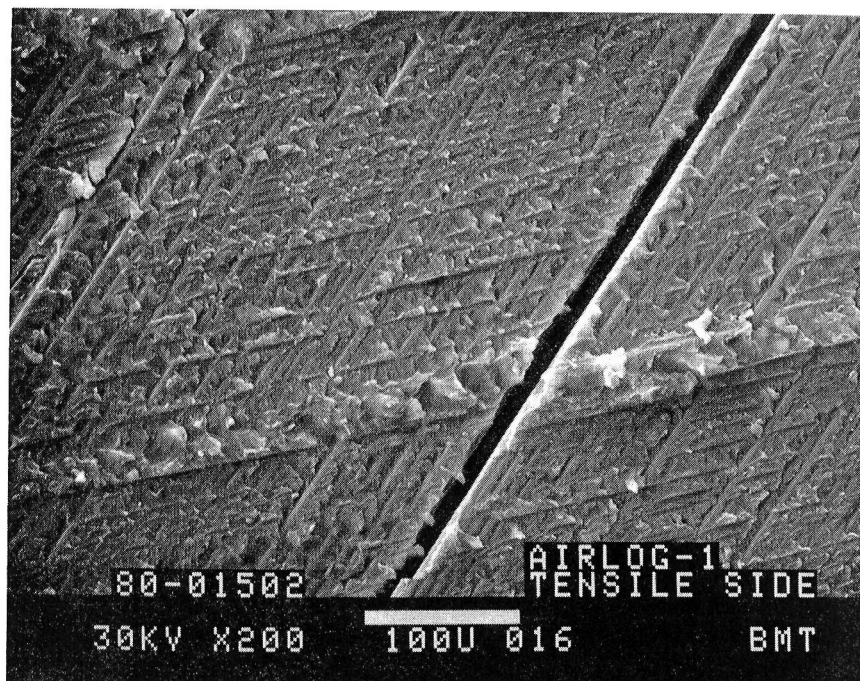
Figure 30. Delamination Face, -45-deg Ply, Air Logistics 1 (200X)

Note plastic flow.

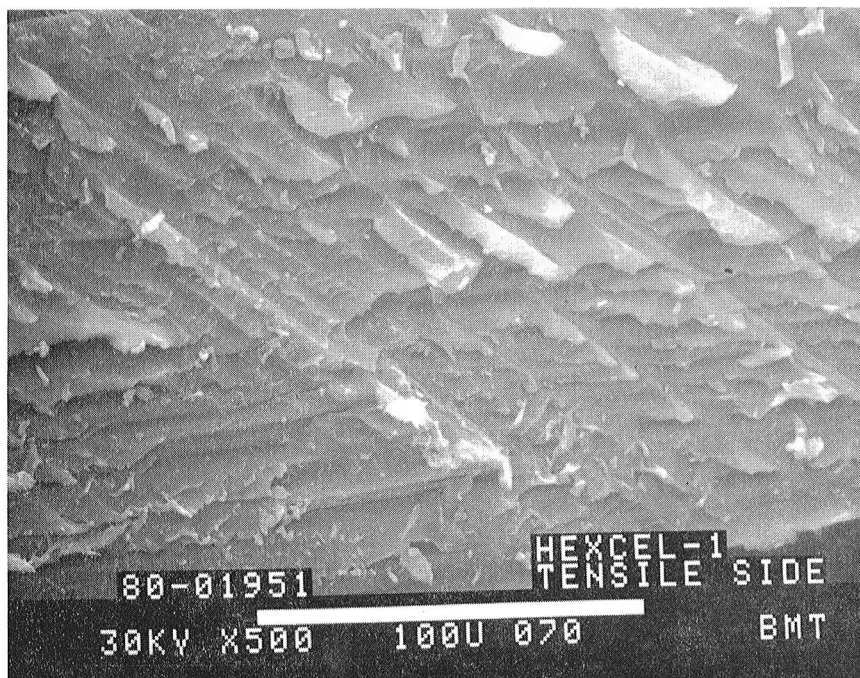
The ductility of the base resin is obvious from Figures 78 through 84. Figure 84 shows resin elongation on the order of $10 \mu\text{m}$ at 5000X, which is conspicuously absent in the case of the nonductile systems.

Figure 78. Plastic Flow on Shear Interlaminar Plane, Hexcel 1 (500X)

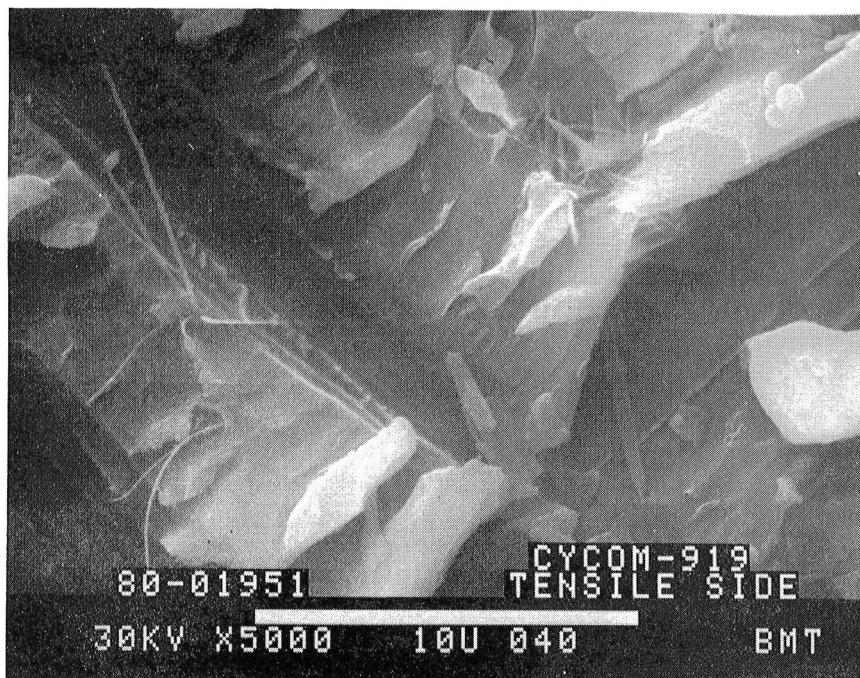
this feature is shown in Figure 87. This magnification reveals the fact that plastic deformation of the resin does occur in this material. This deformation is similar to that of several other specimens used in this study and consists of stretching and feathering of the hackles formed by the intersection of opposing cleavage facets. Several different areas are shown in Figures 88 and 89.

Figure 87. Hairy Appearance, Resin Whiskers, Cycom 937 (5000X)

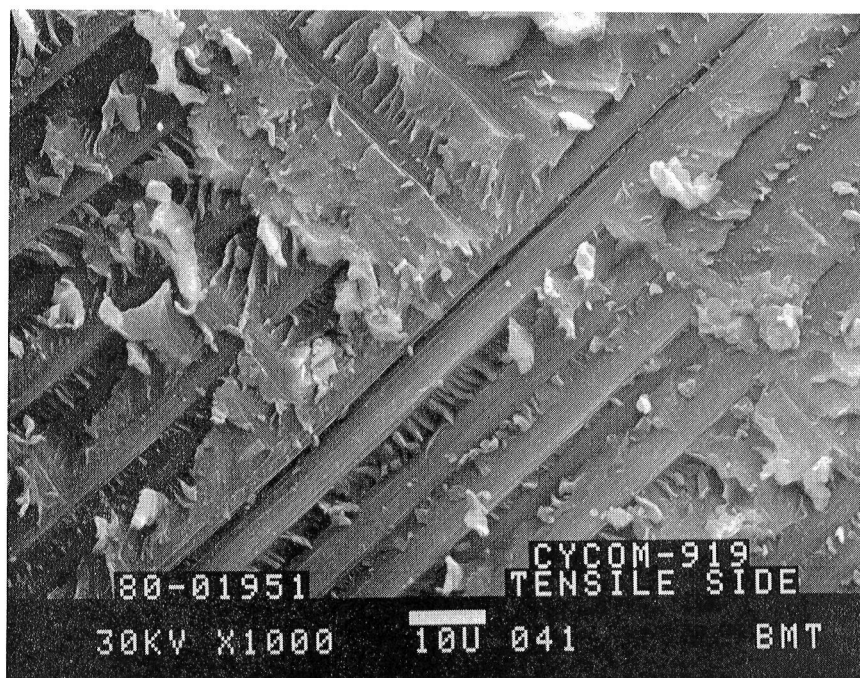
Figure 88. Feathered Hackles Indicating Plastic Flow, Cycom 919 (1000X)

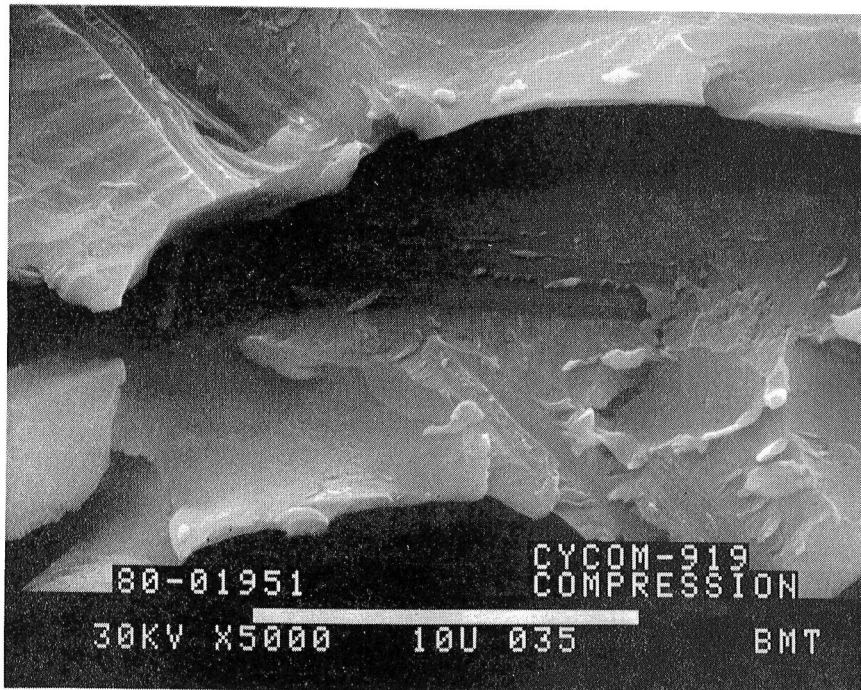
Fiber-matrix bonding is adequate in Cycom 919, as shown in Figures 90, 91, and 92. The fiber surfaces shown in this figure are coated with a thin layer of resin, some of which is plastically deformed.

Figure 91. Resin-Fiber Bond, Cycom 919 (5000X)
